SAFETY Notice

Leg Strap Abrasion

February 2007

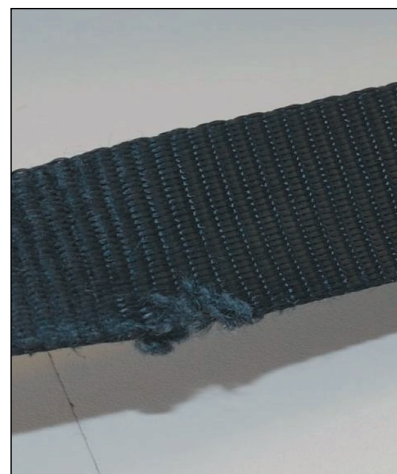
It has been reported on certain harnesses with carbon seat plates occasions of leg strap abrasion across the edge of the seat plate. Even the start of a tear on a leg strap can seriously diminish the strenght of your harness.

Photo 1 : A tear on a leg strap

- If a leg strap is torn (see photo 1), you must not fly with your harness and should return it to a SUP'AIR approved repair centre (details on request).

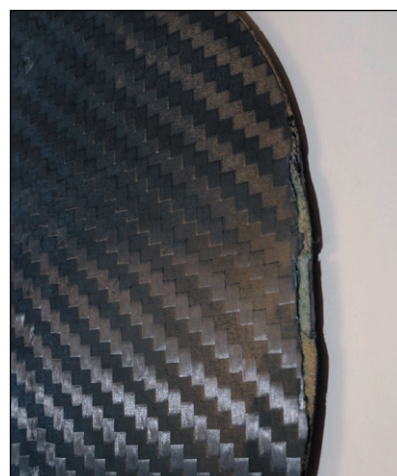
REMEMEMBER : Any damaged carbon seat (see photo 2) may be sharp or abrasive and cause a deterioration of the leg straps and the harness itself. You should always replace such a seat plate.

Photo 2 : Edge of seat plate splintered
